HIGH TIME SERVICE EVALUATION OF THERMAL BARRIER COATINGS
ON THE ROLLS-ROYCE RB211 ENGINE

F. Chris Toriz
Rolls-Royce Inc.
Atlanta, Georgia

Figure 6. - RB-211 service evaluation of engine build no. 2 with 2539 hr/1353 cycles.

Figure 9. - RB-211 service evaluation of engine build no. 1 with 4106 hr/2271 cycles

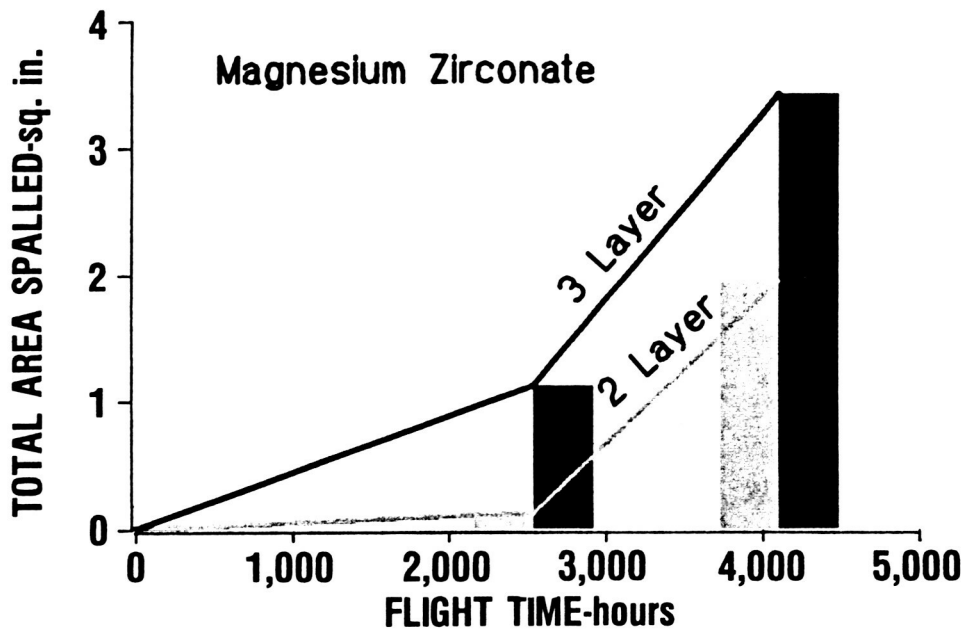
Figure 10. - Service evaluation of thermal barrier coatings on intermediate-pressure turbine nozzle guide vanes.

1. Mag Zirc is not adequate in the turbine.
2. Two layer Mag Zirc will out last 3 layer MZ.
3. Yttria stabilized Zirconia should do the job.
4. To date the Argon Shrouded bond coat looks best.
